# The Bronze Hut Urn in The Metropolitan Museum of Art: Technical Report

RICHARD E. STONE

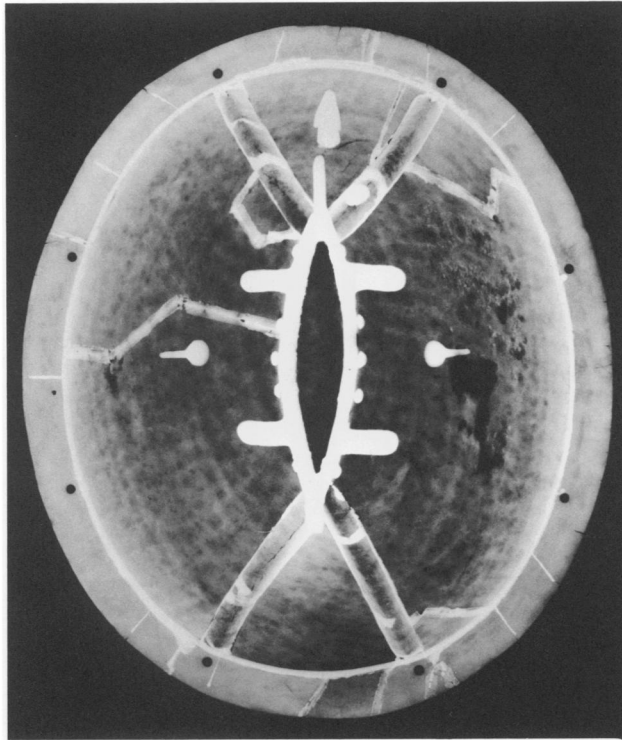
1. The roof after disassembly of the urn

After disassembly, the roof and urn were radiographed separately to better reveal their construction (Figures 1, 2). The roof exclusive of the boat is made of sheet bronze but not in one piece as one might expect. The sloping sections are apparently made of eighteen separate pieces of metal, the edges of which for the most part are cut in precise and rectilinear patterns rather than naturally broken and re-

paired. All the seams are butt-joined with soft solder (an alloy of lead and tin), and many of them are reinforced on the interior with shim brass strips likewise soldered in place. These brass strips were hidden with a heavy application of a colored putty.

The four radial "rafters" divide the roof into four sectors: two long sides and two triangular ends. The radiographs show a distinct hammer texture in the sheets making up the sides and ends, with the hammer blows arranged in concentric rows. There are two different types of hammer marks: one is broad and indistinct; the other is small and quite distinct, produced by a sort of pecking. The broad marks seem to have shaped the slight convexity of the essentially conical roof. The small marks, on the other hand, appear irrelevant to the shaping of the roof and to be instead an attempt to give the metal a distressed surface texture.

The rafters themselves are made of separate strips of metal that show extensive longitudinal cracking as well as a distinctly darkened surface, indicative of severe cold working and annealing. The metal is so cracked that it must indeed have been previously embrittled by corrosion, as the actual degree to which the metal is embossed is not that great. The working and annealing were obviously done before the roof of the urn was assembled by soldering.

The eaves are also formed from a separate piece of metal and have numerous quasi-radial cuts. Most of these cuts do not traverse the full width of the metal, and all have been filled with soft solder.

Clearly, the eaves must have been made from a longitudinal metal strip which had triangular gores cut on the inner side to enable the strip to be bent into a flat polygon approximating an ellipse. The shape was further refined by bending and filing, and the gores, now reduced to seams, were filled with solder. The eaves were then joined to the roof by soldering, the seam being hidden on the exterior by the round molding. On the interior the raw filed edge of the seam is quite conspicuous, even where the paint has not been removed.

It is obvious that the roof was executed by someone trained in the methods of the modern copper-smith, who works with metal that is preformed into sheets. A preindustrial craftsman would almost certainly have fashioned the roof just as he would have made a bowl, by raising it in a single piece. The complex piecing of the roof is primarily an effort to avoid the technique of hammer raising. Nowhere in the en-

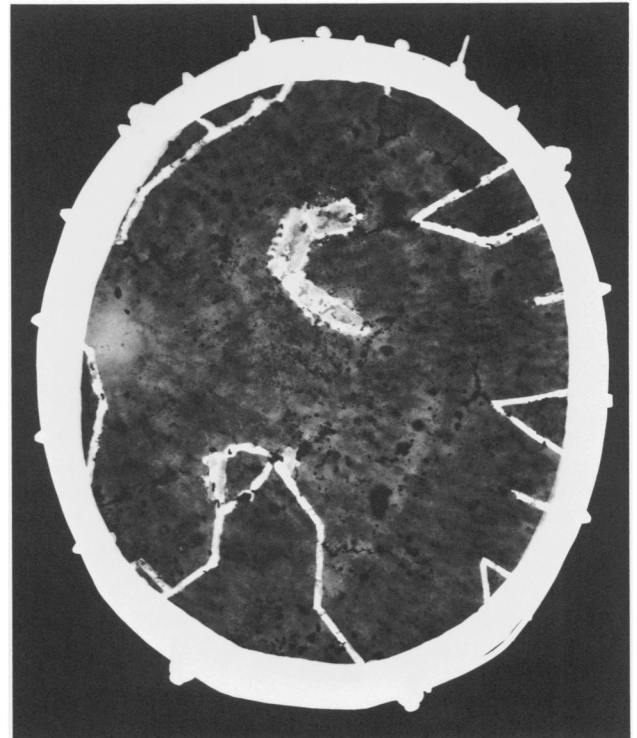
2. The bottom after disassembly of the urn

The bottom of the urn, like the roof, is made of a metal sheet carefully pieced together with soft solder and brass reinforcing strips. The bronze is considerably thinner than that of the roof and is riddled with penetrating corrosion pits. Much of the patching

seems to have been done in order to mend the corroded metal rather than to serve any structural function as in the roof. The metal sheet has apparently been cut from the bottom of a much larger flat-bottomed vessel, for in the radiograph one can see a typical pattern of concentric hammer blows not around the center of the elliptical bottom but around a thick spot virtually at its edge. There are no small "pecking" hammer marks since the metal here, unlike that of the roof, had a sufficiently irregular surface to begin with.
